Ohio Department of Natural Resources

Technical Report

A Functional Assessment of Stream Restoration in Ohio

By Daniel E. Mecklenburg and Laura A. Fay

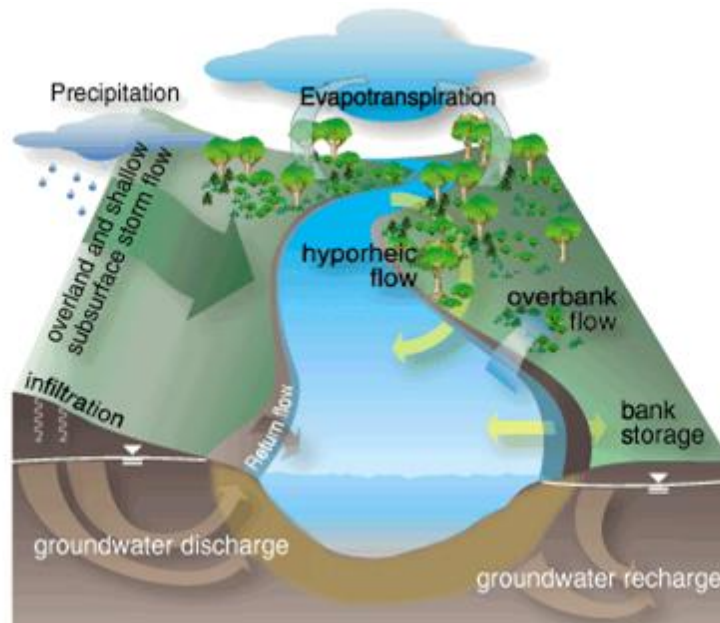
Figure 2 Water movement through streams emphasizing pathways between channel and riparian area. (From the Committee on Riparian Zone Functioning and Strategies for Management, 2002. Reprinted with permission from the National Academies Press, Copyright 2002. National Academy of Science. Riparian Areas; Functions and Strategies for Management).

In addition to a stream’s form and processes, another physical aspect is the material of which it is composed, its subsurface lithology. Streams do not simply flow over an impermeable two-dimensional surface, but flow through banks, beds and floodplains laterally and vertically (Figure 2). Ground water and shallow hyporheic water flow through channel bed material and riparian soils. Van der Putten (2004) described the ecological services provided by natural floodplain soils including retention of nitrogen in biomass, physical stabilization, interception of runoff, moisture retention, evapo-transpiration and carbon sequestration. For these, he described the necessity of soil supporting soil organisms (bacteria, fungus, nematodes, protozoa, earthworms and isopods). The material composition of a streamway has an intricate role in its ecological functions and is certainly manipulated by restoration work.

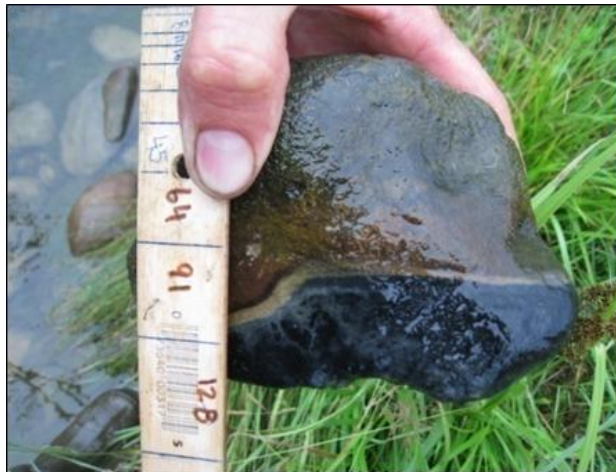
Figure 25 Dark stain on rock from embedded riffle indicating chemical reduction.

Surface bed material was assessed at riffles. An attempt was made to distinguish between mobile riffle surface material and material placed during construction. Pebble counts were performed for gravel and coarser material according to Ward and Trimble (2004) based on the technique by Wolman (1954). Silt and clay bed material was recorded based on visual and tactile observation. Embeddedness was noted as highly or moderately embedded as evidenced by silt and clay filling gravel or cobble interstices. Black staining on the buried portions of large

particles and the absence of macroinvertebrates on those surfaces were used to indicate anoxic conditions.

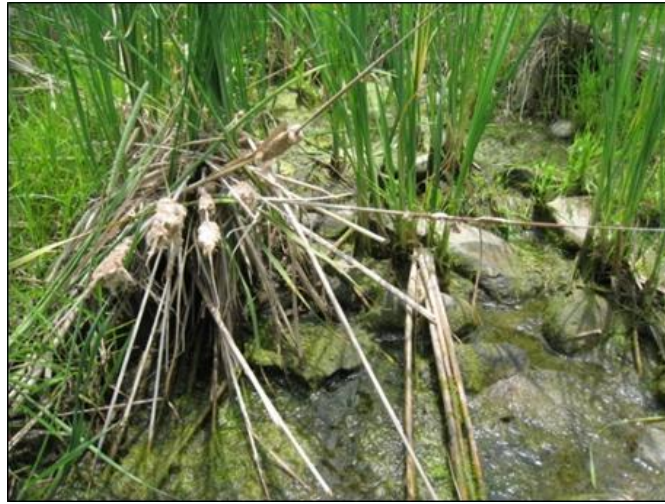
Figure 26 Riffle colonized by hydrophytic vegetation at the Slane residential site.

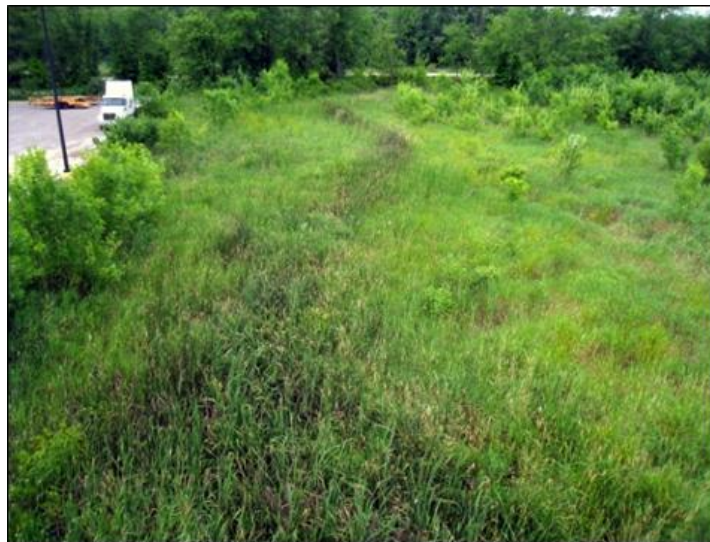
Figure 27 Constructed meandering channel colonized by vegetation at the Millersburg Walmart site.
